# Root Cause Analysis

Booster Station 150 Stainless Steel Piping Failure

**Kuwait Oil Company  
Gas Management Group**

*28 November 2007 (Bahrain)*

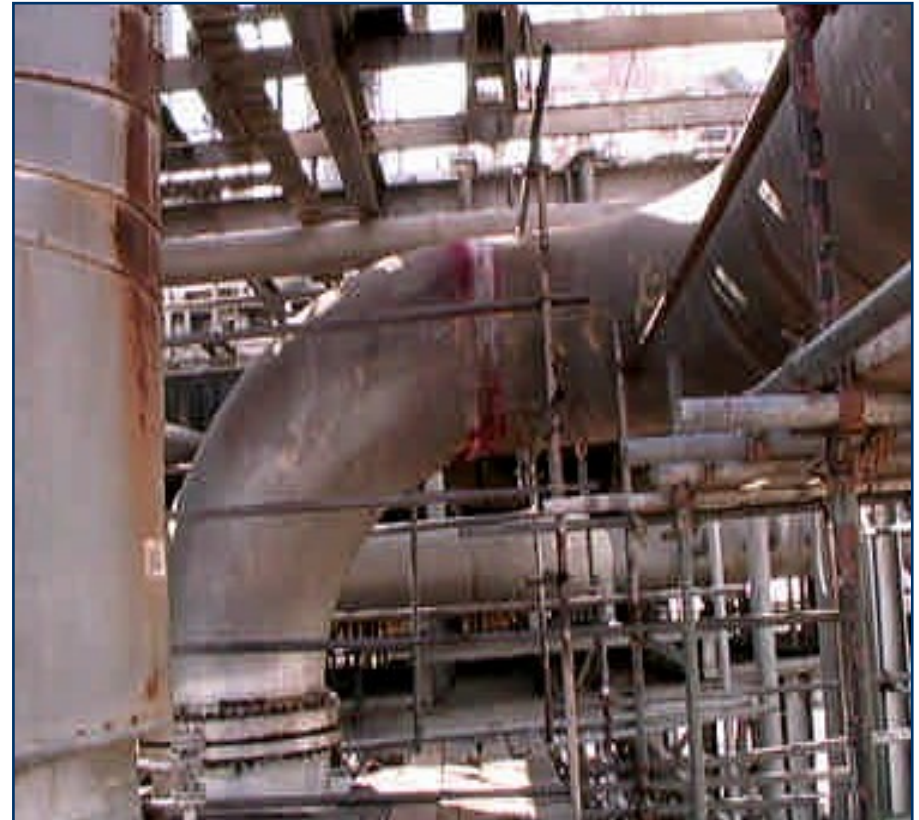
- On March 9, 2005 minor oozing of gas & oil occurred from the bottom portion of weld joint inlet piping (42" dia, stainless steel 321) of a low pressure gas suction scrubber of Gas Booster Station (BS) 150 Train III.

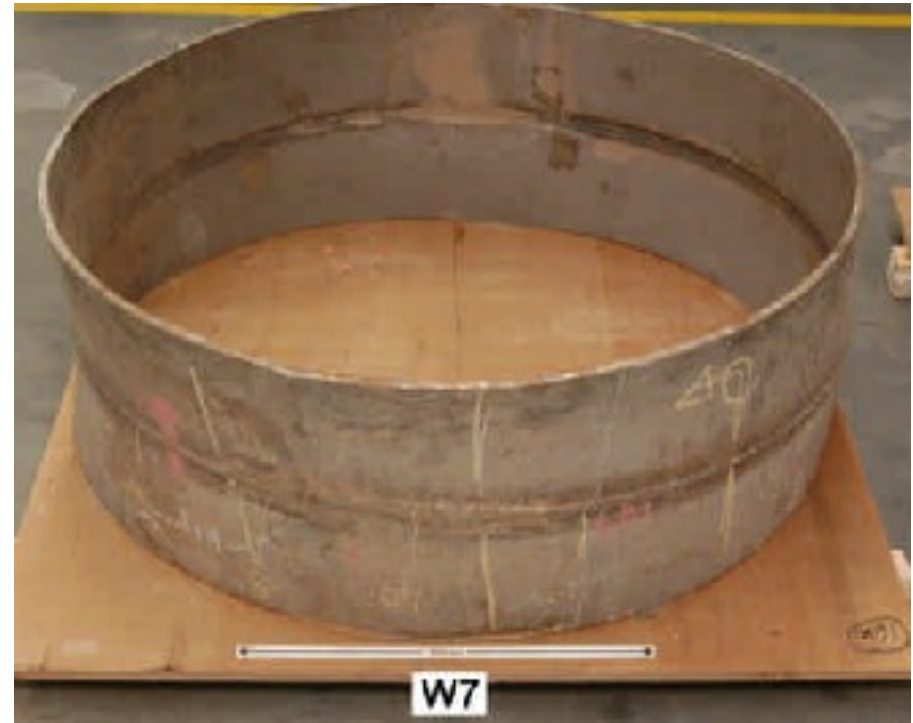
- Crack was visible at 6 o'clock position on scrubber inlet pipe
- Corrosion products is visible on the inside pipe in the weld area

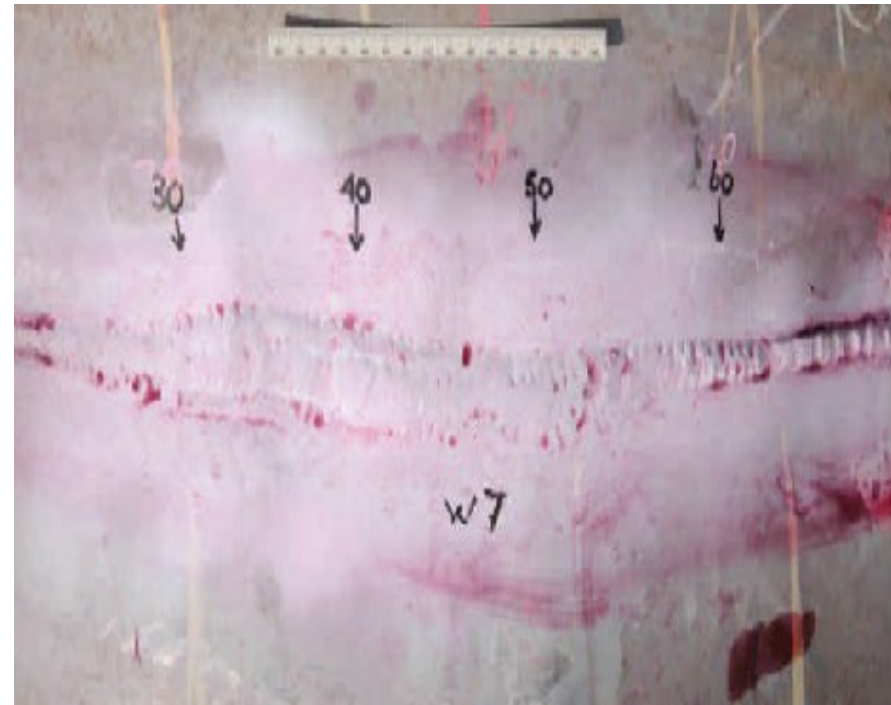
- **External surfaces of welding seam was cleaned and visually inspected using Soap Solution and Dye penetrant. Presence of any surface indication was not revealed.**

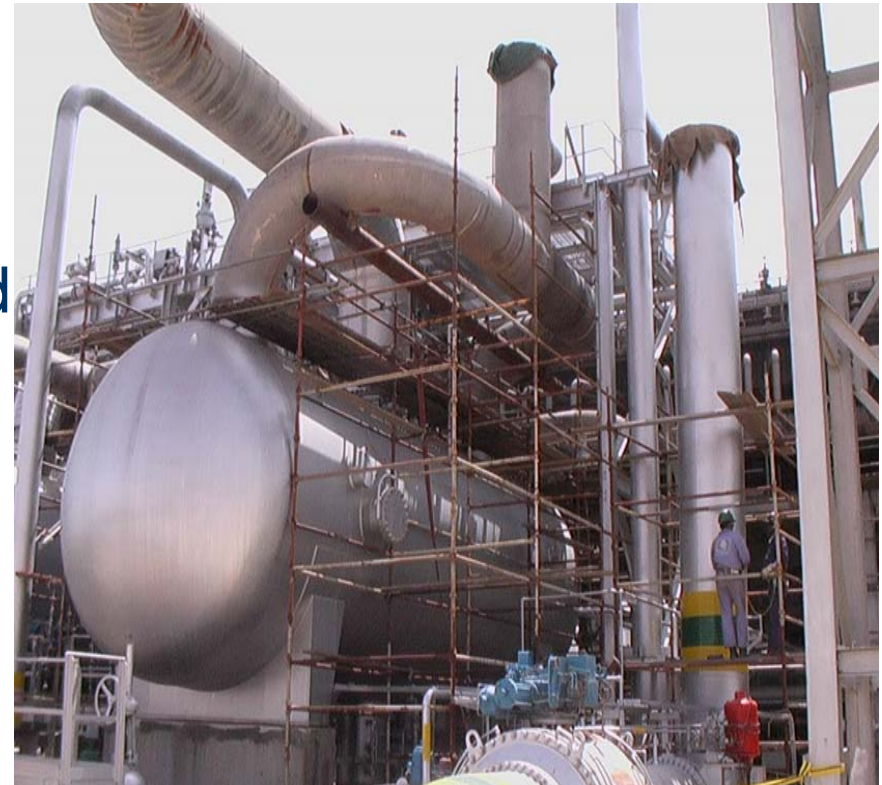
- A crack was also observed in Train II by ultrasonic scanning. This crack had not penetrated the entire wall thickness but had become quite large & deep to give a leak in the near future.
- This train was also recommended for a shutdown for carrying out the replacement.

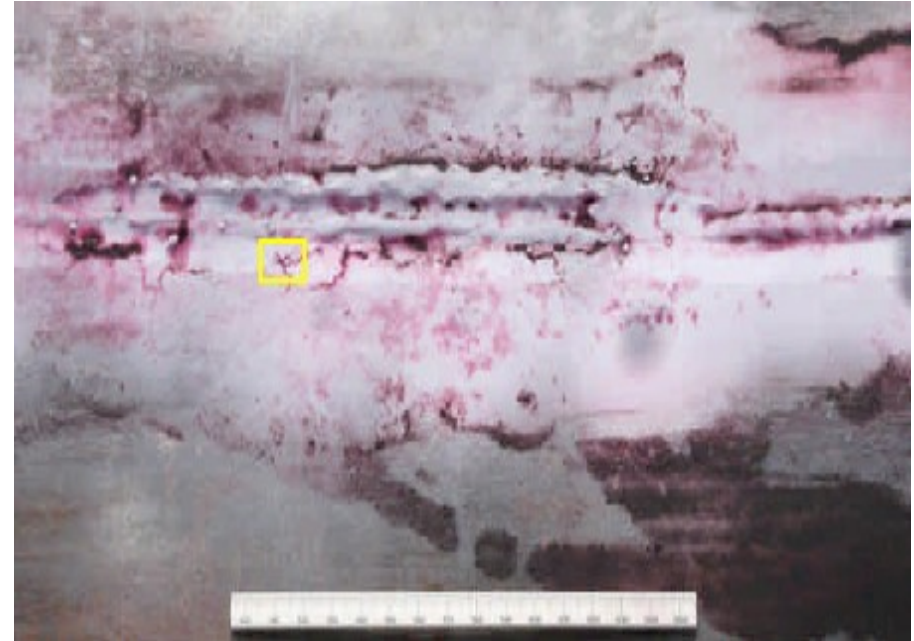
A spool piece was cut from the (42" dia.) affected piping and the internal surface was subjected to dye penetrant testing which revealed several cracks having typical pattern of stress corrosion cracking.

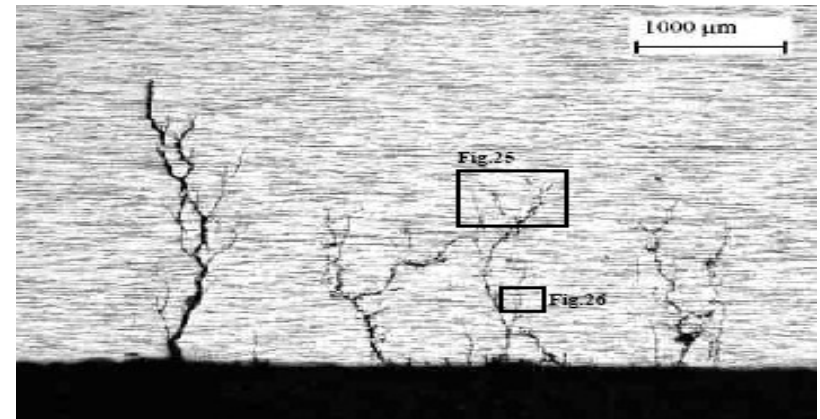
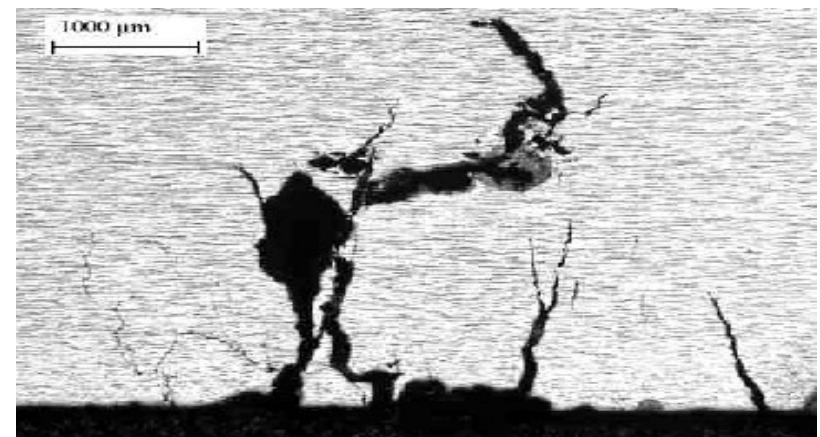
- **Metallographic Micrographs conducted by TWI (The Welding Institute, UK) revealed:**
  - **The presence of several branched in both intergranular and transgranular cracks due to SCC and**
  - **Large amount of deposits inside the piping which can be the probable source of corrosion mechanism**

- Cracks are initiating from the parent metal crossing the weld metal and propagating on the other side into the parent metal.
- Large pits are also visible with several cracks originating from the same.
- It can also be revealed that the severity of cracking is more in HAZ than in weld metal or parent metal.
- Microphotographs also reveal the cracks to have a transgranular pattern.

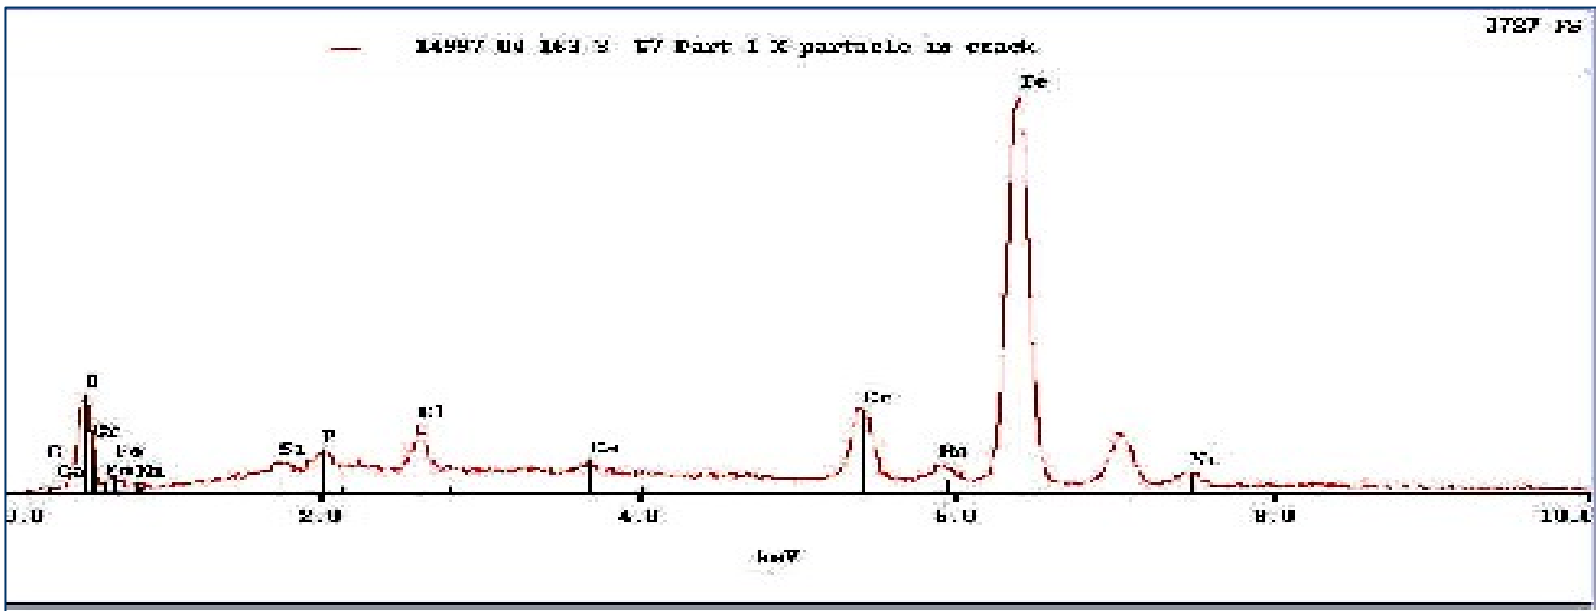
Energy Dispersive X-Ray analysis (SEM-EDX) conducted by TWI (The Welding Institute, UK) showed the corrosion products to be rich in oxygen and chloride species
