# Root Cause Analysis

Booster Station 150 Stainless Steel Piping Failure

**Kuwait Oil Company  
Gas Management Group**

*28 November 2007 (Bahrain)*

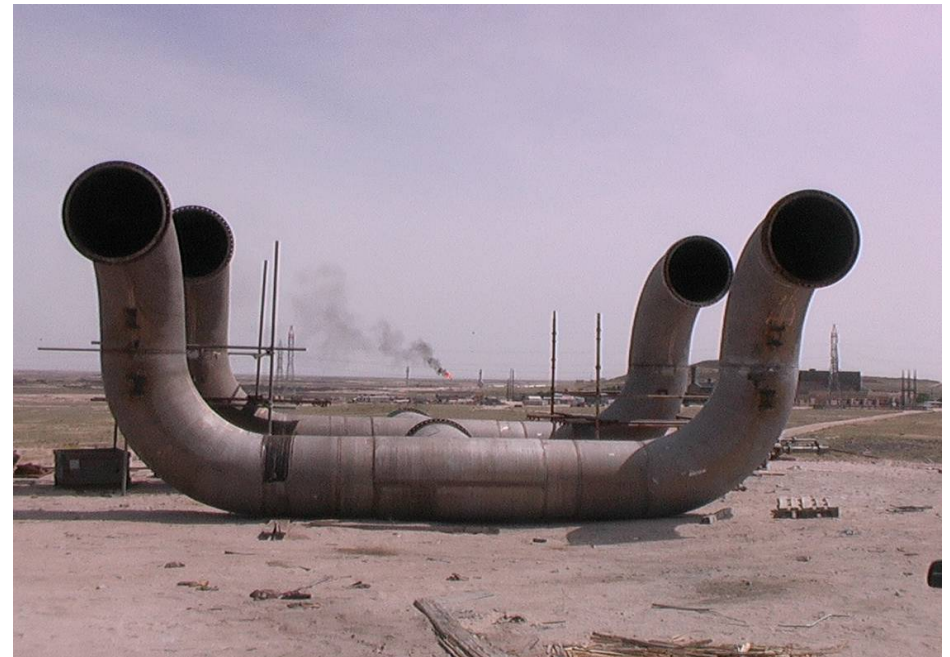
# RCA Steps

- The RCA was conducted by using a four step process involving:
  - Data collection
  - Causal factor charting
  - Root cause identification
  - Recommendation

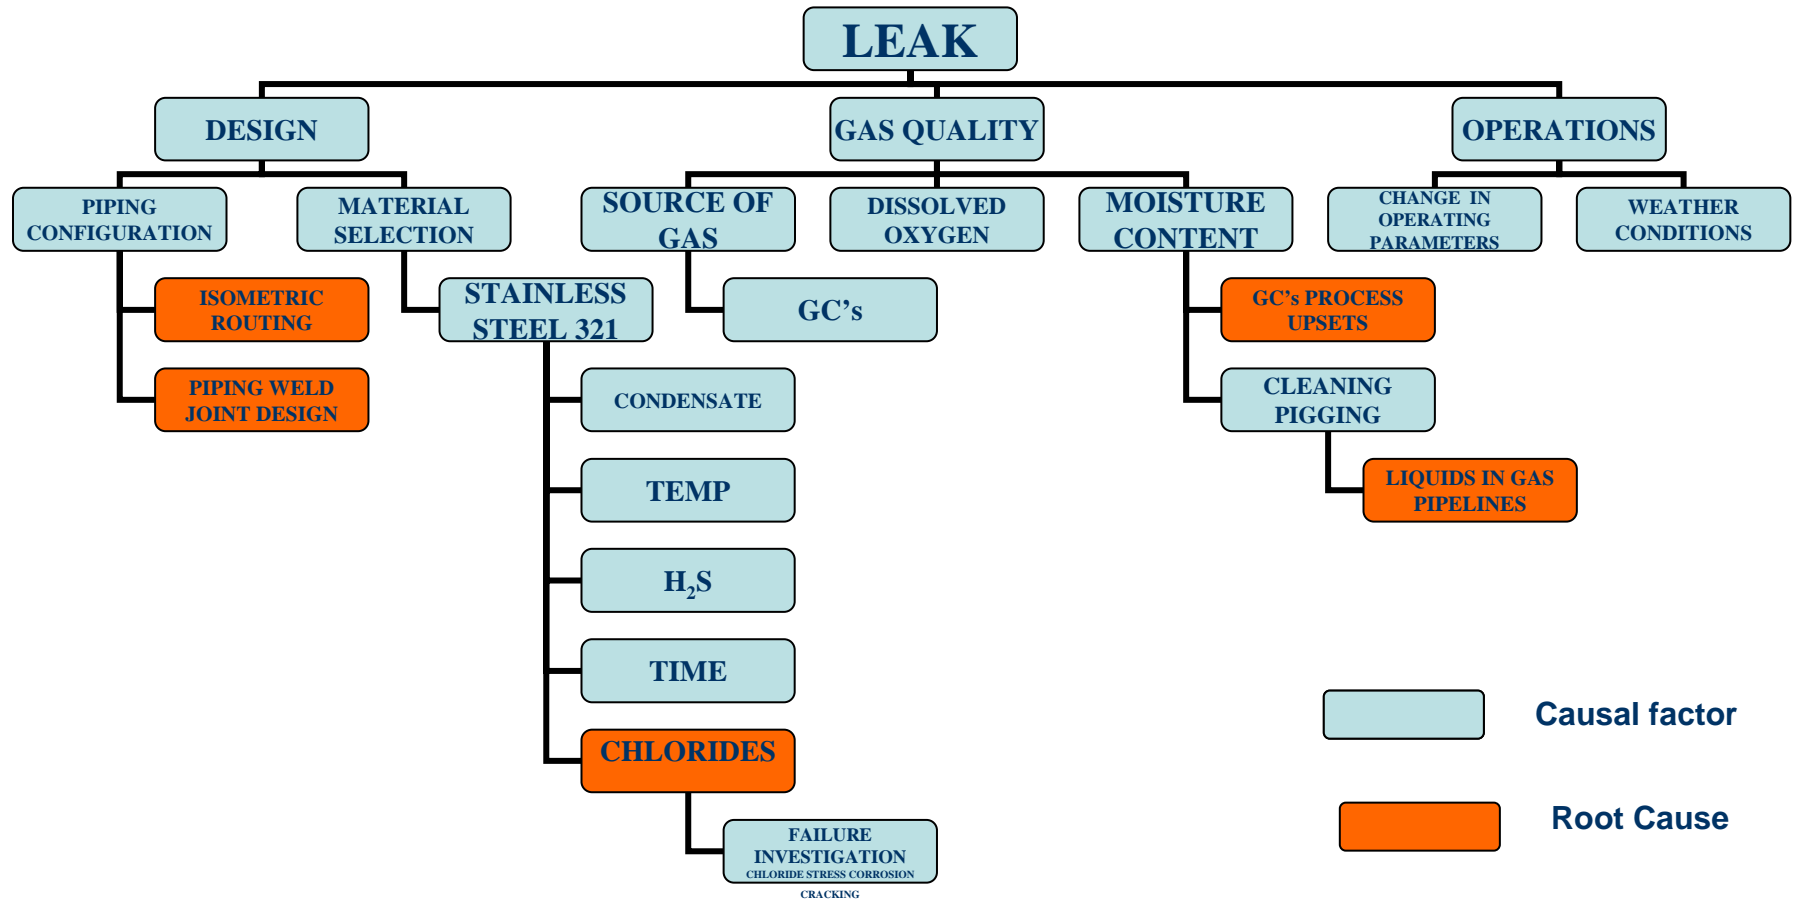
# Summary Fault Tree for the Incident

- ***Equipment Problem (Main Event):***
- **Design Problem**
  - Original Design documents
  - Design philosophy
  - Document control
- **Reliability Problem**
  - Equipment reliability program
  - Preventive maintenance
  - Predictive maintenance
- **Operations Problem**
  - Operating / maintenance history
  - Operating procedures / neglect
- **Process Problem**
  - Change in process parameters
  - Change of source
  - Safety / hazard review
- **External Factors**
  - Environment
  - Administrative Management Systems
  - Tampering / misuse
